INSPECTION GUIDE

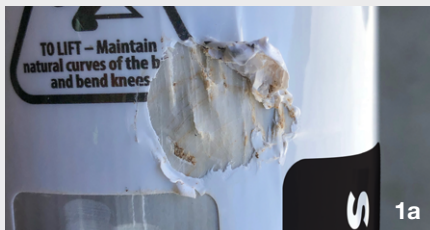
(1a) It is clear that the stand has been impacted. As you can see, the vinyl label has been damaged and delamination has occurred in the area. While the damaged specimen passed a WLL test, ANY STAND with this type of damage SHALL NOT be used.

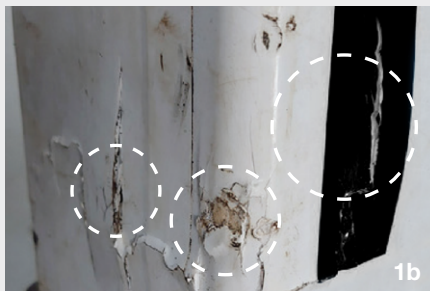
(1b) Indicates visual signs of impact damage on the corner of the column, note the patch of vinyl missing in the impact area, and the splitting in the vinyl where the column has delaminated. Any stand displaying this type of damage SHALL NOT be used.

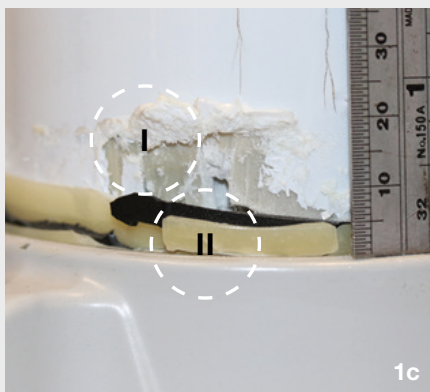
(1c) Offers three (3) different examples that users should be trained to look for during pre-use inspections.

- I. Riffeling of the vinyl label at the base of the stand where the composite column connects to the stand base. This is a sign of improper use in the form of overloading, excessive side loading or having applied excessive rotational forces to the column or dynamic (shock) load the stand.
- II. Note the damage to the black plastic boot. This can also be a sign of improper use in the form of overloading, excessive side loading or having applied excessive rotational forces to the column or shock loading the stand.
- III. The inner surface of the 15-tonne composite column should be visually inspected. Invert the stand to inspect the column inner surface between the filled section of column and the base of the stand for any signs of delamination.

N.B. Resin may be observed on the edges of the inner area of the base, see image IV. This is residual material from the assembly process. This is normal and not a reason for concern.

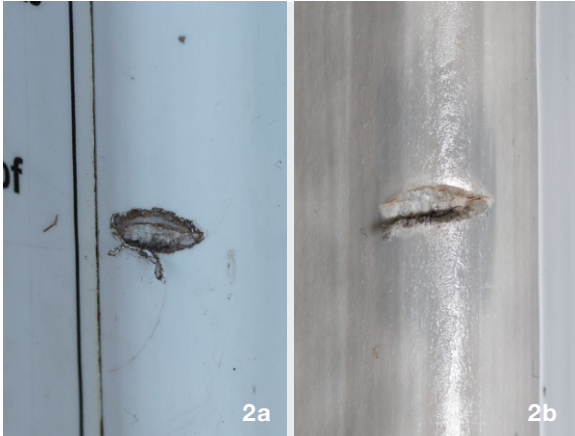
Photos **(2a and 2b)** are examples of concentrated damage to a composite column that is greater than 1mm deep. Even though there are no signs of delamination, this level of damage should be referred to your local distributor prior to using the stand.

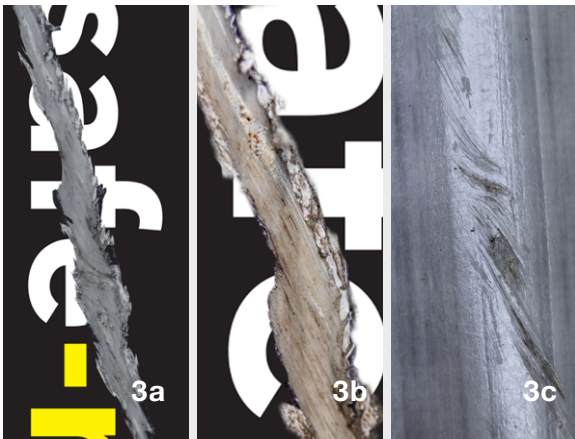
Should damage to the composite column be identified, the vinyl label can be removed to assess the damage to the composite material properly. In this example, visual damage appears significant **(3a and 3b)** however, with the label removed **(3c)**, there was only minor damage to the column (less than 0.5mm) with no signs of delamination. This unit passed a WLL test.

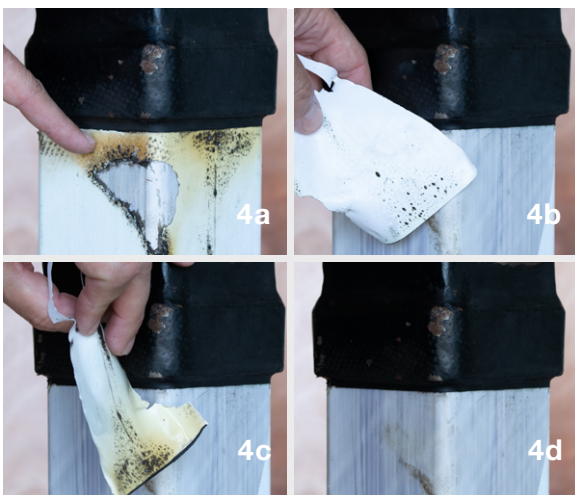
safe-n-lite stands are not ideally suited to hot work and have an operating temperature range of between -15°C and 75°C. Visible signs of heat damage **(4a)** will appear in the vinyl label long before the composite material is compromised.
